**CONSERVATION OF BUDDHIST-ERA  
BUILT HERITAGE, SHEWAKI  
KABUL, AFGHANISTAN  
2020-22**

# STUPA-E SHEWAKI

CONSERVATION AT BUDDHIST-ERA  
BUILT HERITAGE, SHEWAKI,  
KABUL, AFGHANISTAN

Afghan Cultural Heritage Consulting Organization

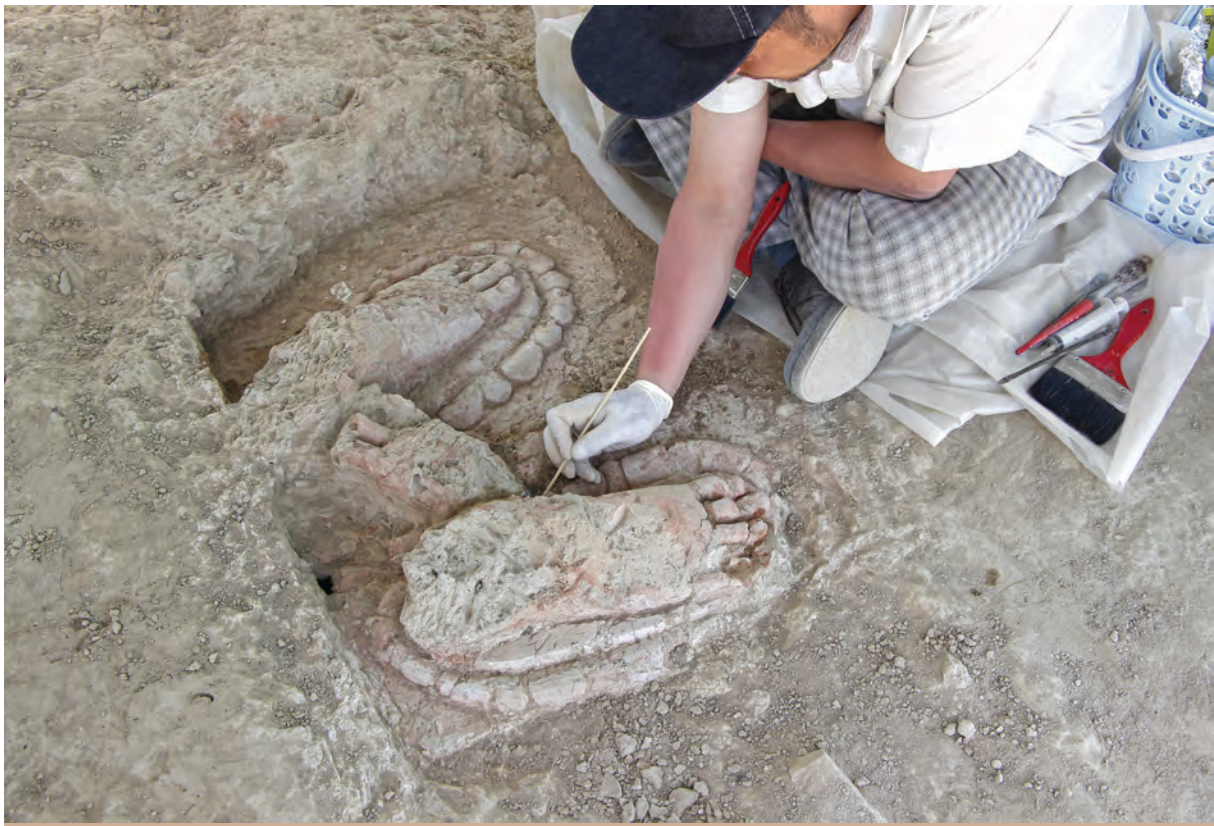
Ongoing conservation of remains of stucco sculpture on outer platform 2022

Fragments of clay and stucco figures excavated in what are likely to have been chapels on the outer platform at Shewaki were probably endowed over time by donors. Construction on this scale would have required considerable resources and, at a period when trade and commerce generated significant wealth among a mercantile class, one or more of whom may have commissioned the stupa itself. Donations from pilgrims doubtless contributed to meeting a proportion of the expenses of monastic orders, but it is likely that they also had land holdings that would have generated additional income.

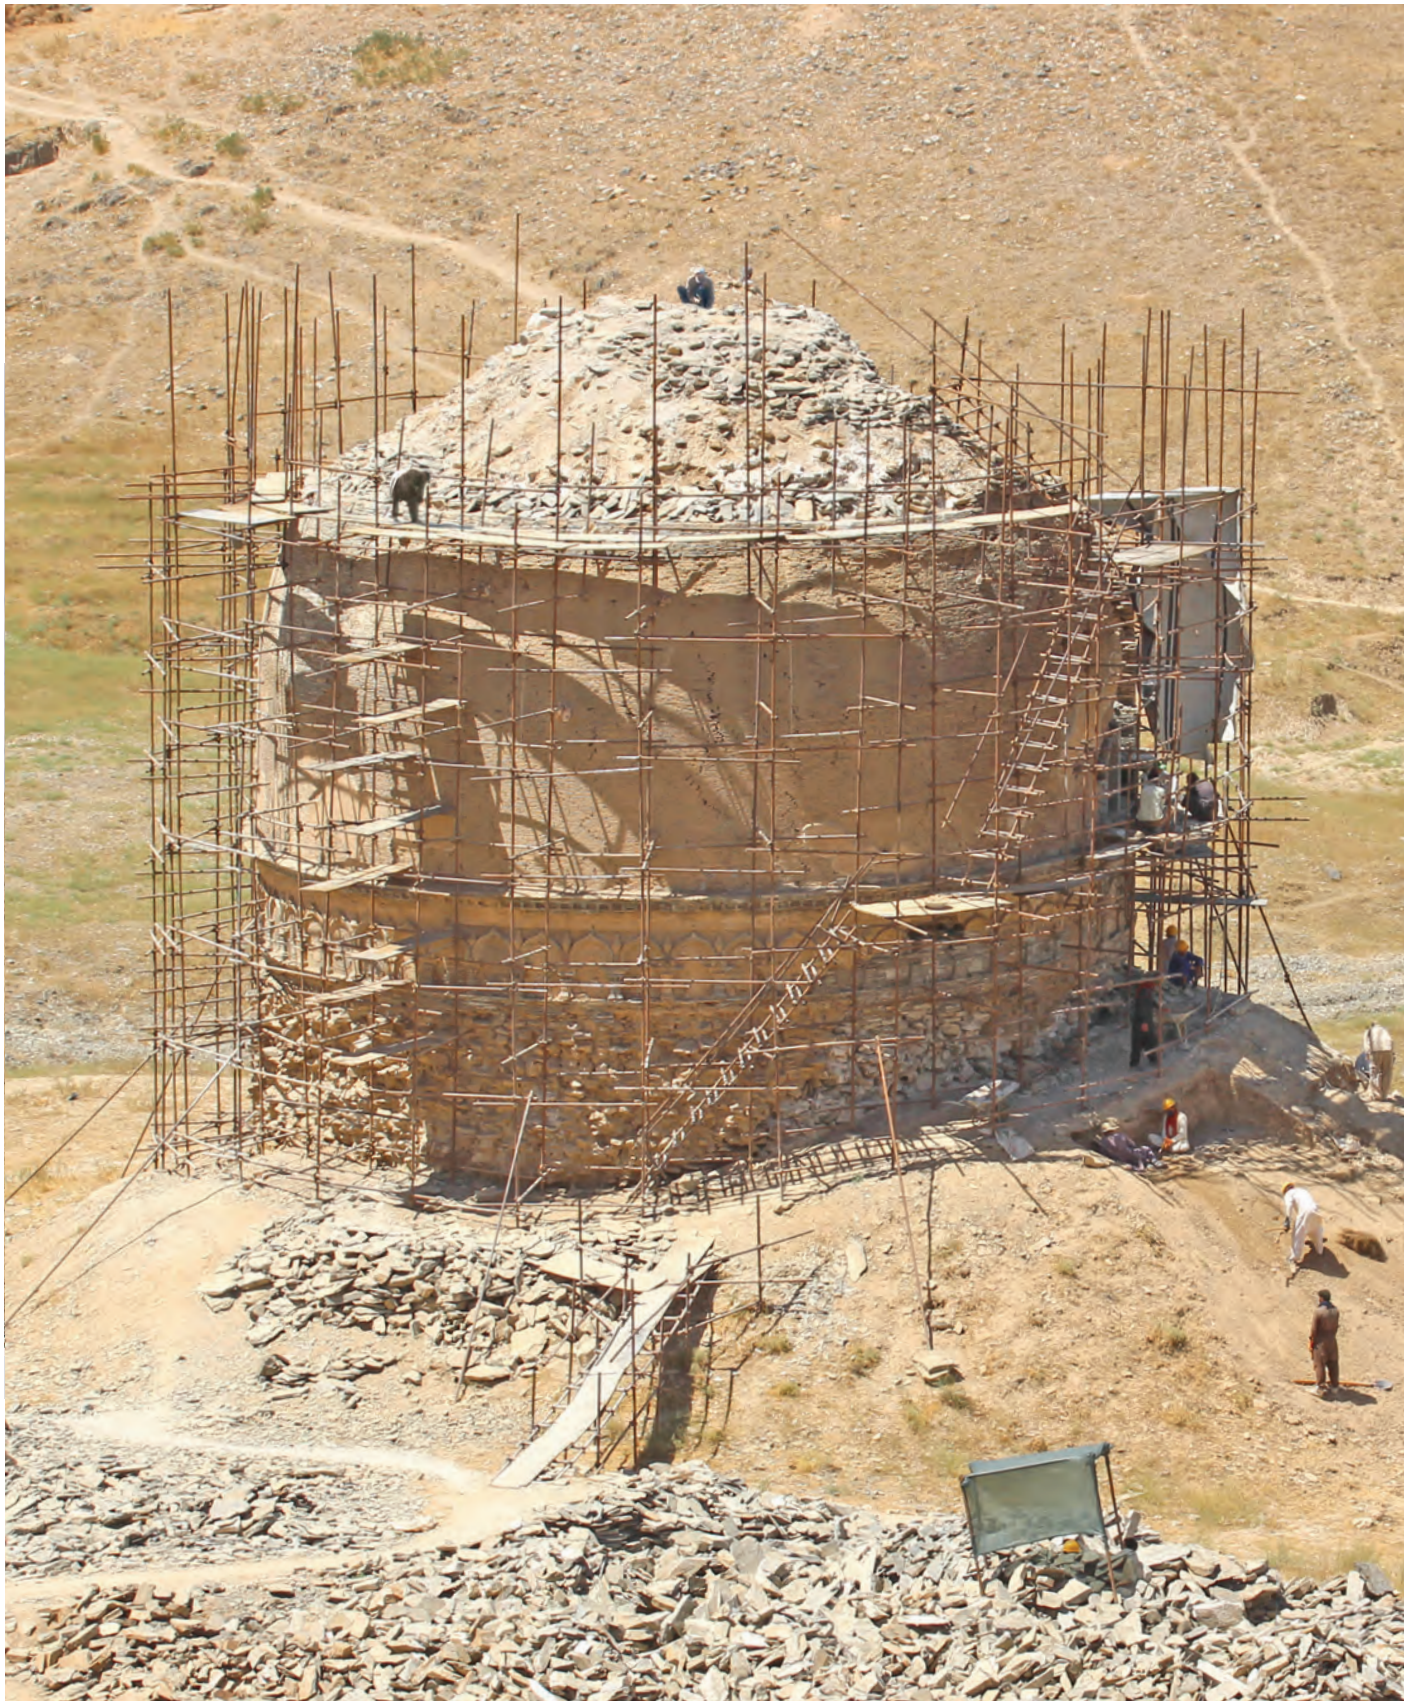
Following discussions within the project team, it was resolved to reconstruct the dome in order to ensure the stability of the structure as a whole<sup>xvi</sup>. Unstable sections of masonry in the core of the dome were therefore stabilized by removal of loose material and application of a lime slurry, before the cavities were backfilled with rubble stone (much of it retrieved from the mound around the stupa) set in mud mortar, as in the original fabric. The damaged reliquary was repaired and closed off during the course of this work.

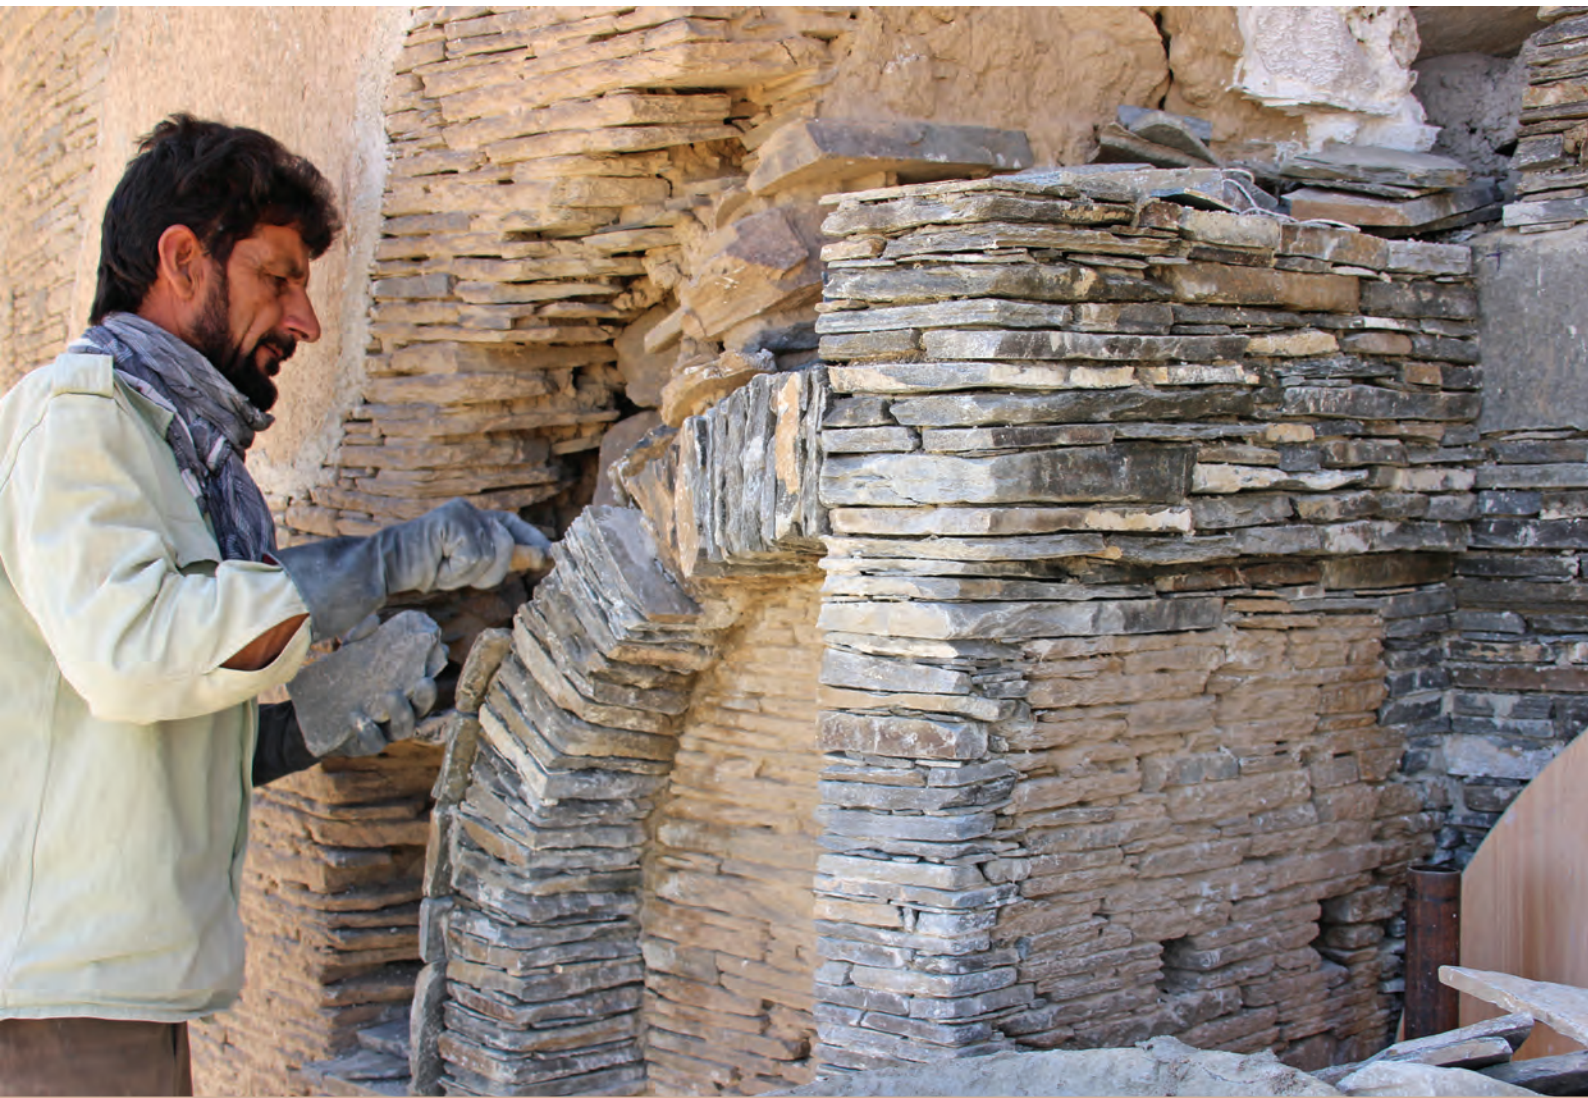
Reconstruction of the north niche on the stupa drum 2021

As in other examples in the region, the stupa at Shewaki has a prominent niche set into the lower drum that is aligned with the main stair to the *anda* – in this case which is oriented to the north. Although badly-damaged, it was possible to identify the dimensions of a deep niche (measuring 1.5m wide, 2.2m high and 80cm deep) flanked by two shallow half-niches, all of which were reconstructed. It is likely that the central niche housed a figure of the Buddha, perhaps with decorative panels fixed on either side.

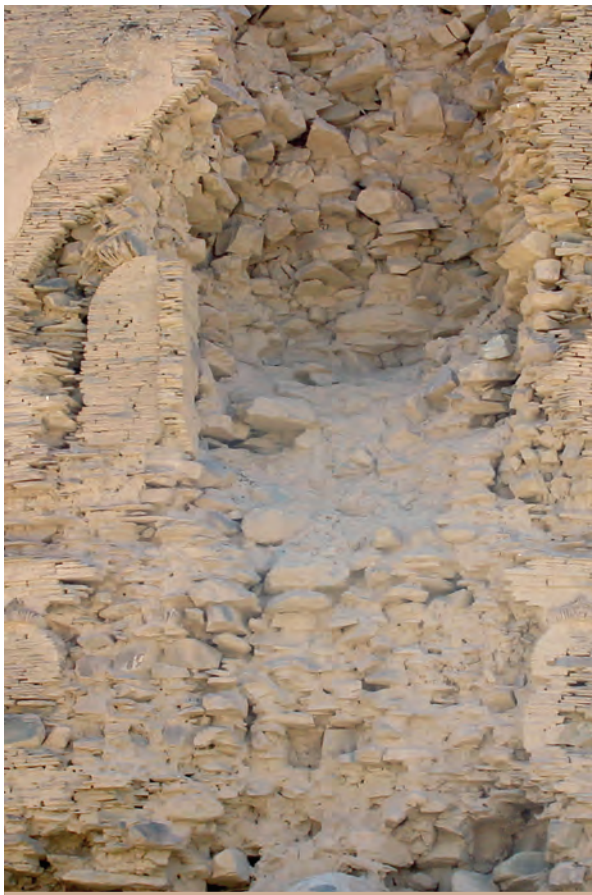
North niche and arcade prior to restoration 2020

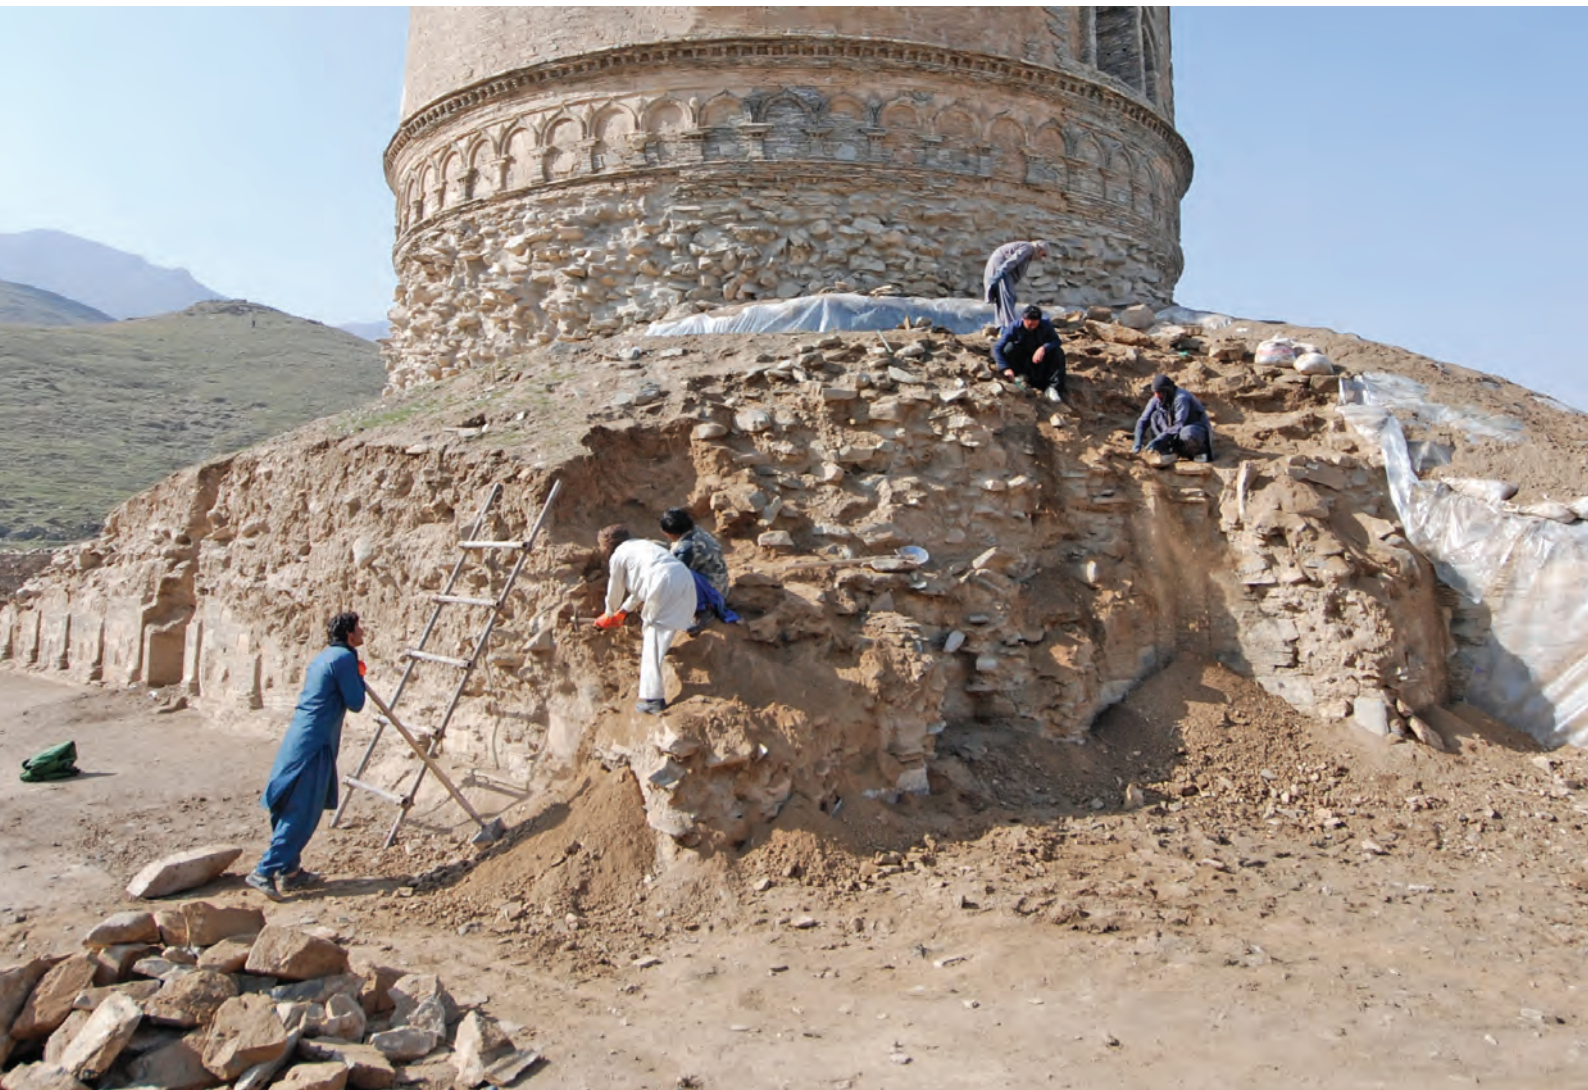
Ongoing excavation of the stupa platform 2021

Following removal of the scaffolding around the drum, excavation of the mound around the stupa revealed sections of masonry that formed part of a square *anda* measuring 22.5m across. From these remains it was possible to determine details of the original articulation of the lower part, around which a narrow plinth extends 1m from the external walls of the *anda*, and is 90cm above a band of stone paving. The elevations of this plinth have pilasters at 1.5m centres, topped with sandstone capitals bearing a double-spiral motif.

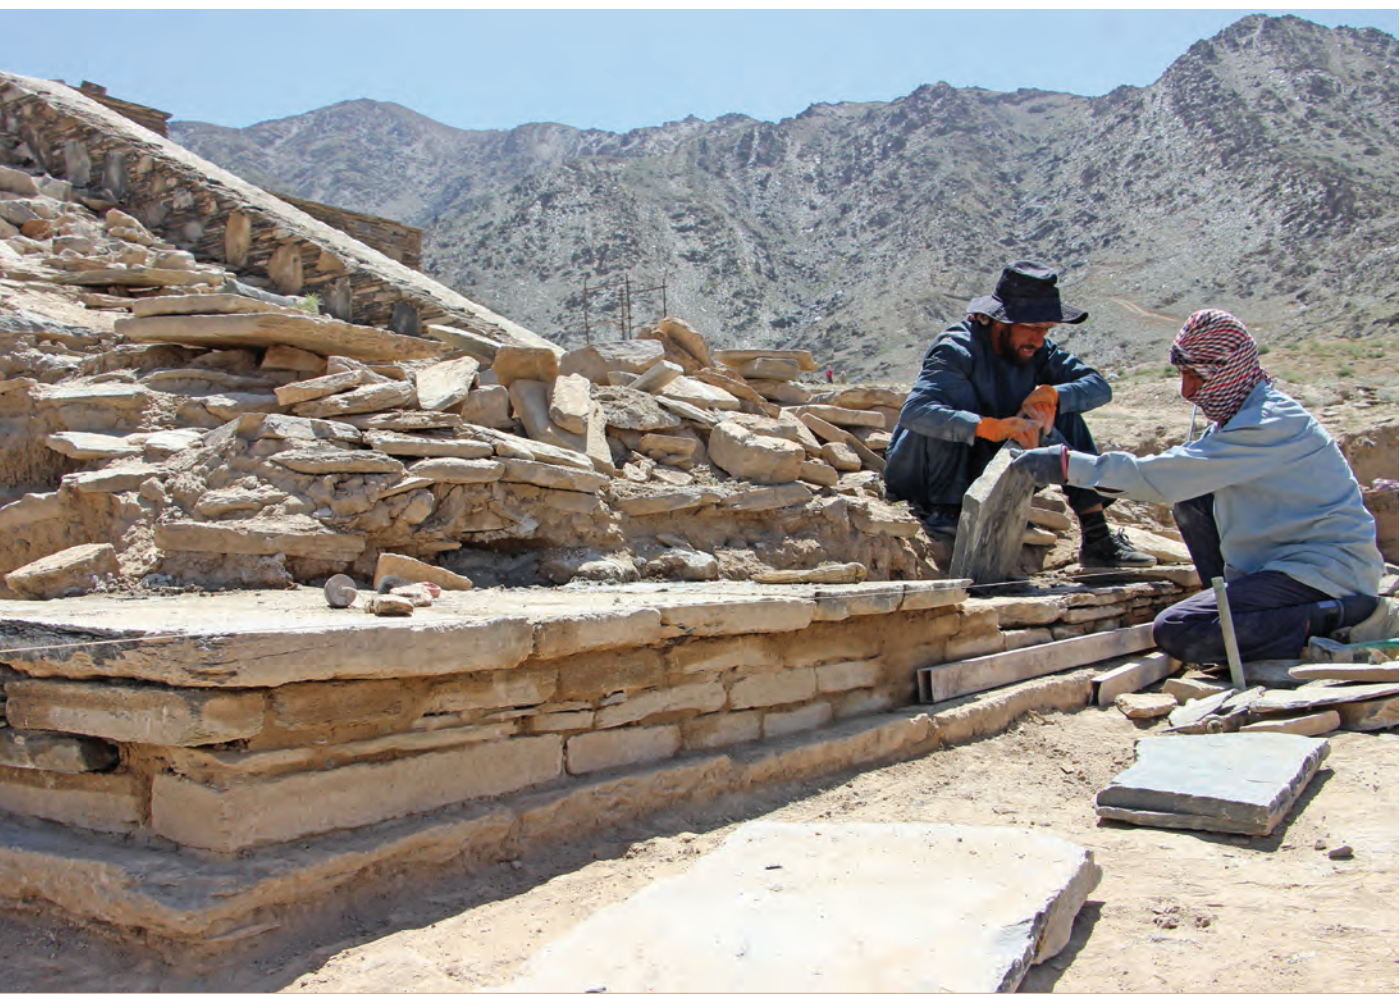
On the north side of the *anda*, remains were found of a stair that is approximately 6m in width and extends almost 12m towards an outer platform. Excavations in this area revealed evidence that the lower part of the stair was altered at some stage, with the addition of a landing and an additional short flight of steps to the north. The flanking walls of this stair retained, on the east-facing side, remains of inclined articulation of a type not recorded on other stupas in the region. Based on dimensions taken from several of the original steps that were excavated, both the stair and flanking walls were subsequently reconstructed. In the absence of any indication of the treatment of the parapets of the flanking walls, these were left unfinished.

Ongoing conservation at the base of main stair 2022

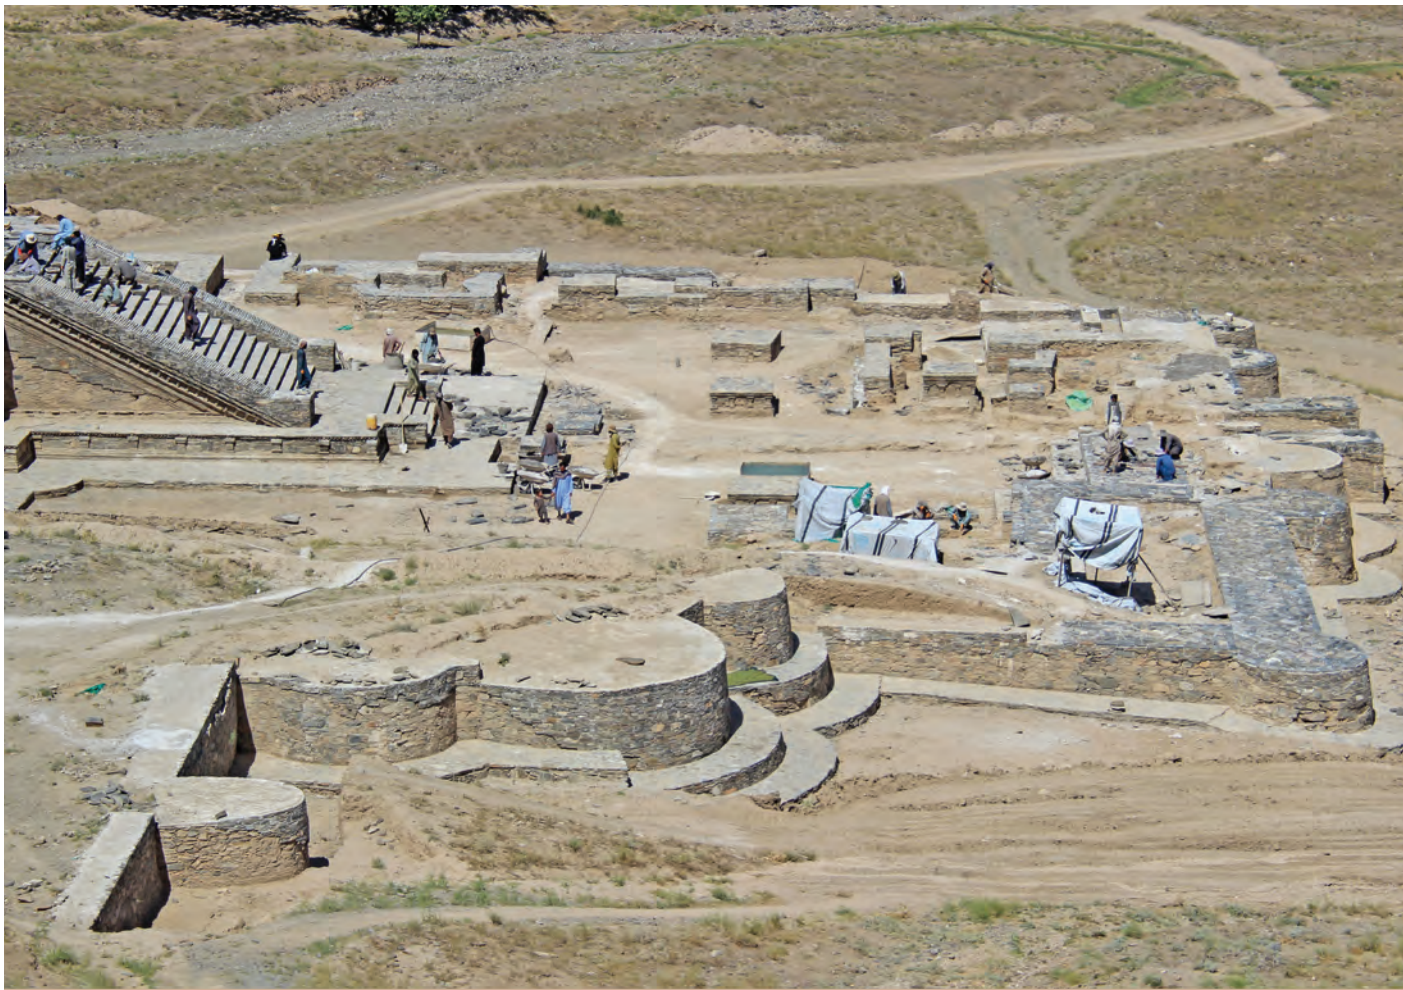
North part of outer platform from the east with conserved perimeter walls and secondary stupas 2022

These structures are located on an outer platform measuring some 78m by 55m overall and that appears to have been constructed in several stages. Along its northern and western edges, where the natural ground level falls away, excavation revealed substantial stone masonry walls with semi-circular bastions that appear to have had a defensive purpose. Inside the north-west corner of the outer platform, traces of a lower space were found during excavation, along with enclosed corridors running parallel to its western edge. After repairs to these walls, a strip of stone paving was laid along the parapets as a protective measure.

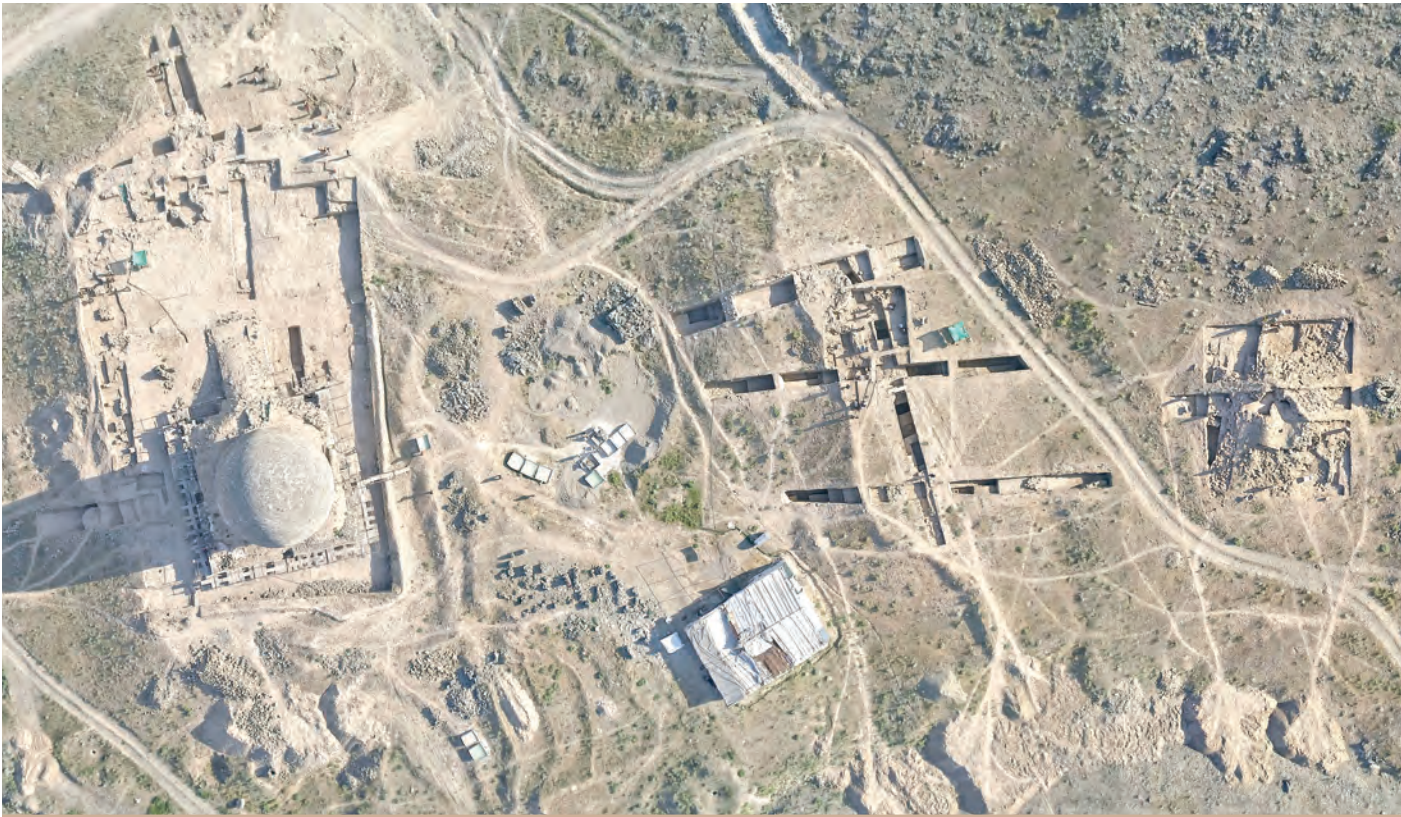
The wall along the north side of the outer platform extends some distance to the east, and possibly enclosed a *vihara* or monastery. Excavation of a number of trial trenches in this area revealed sections of stone masonry walling, parts of which are superimposed and vary significantly in quality of workmanship, suggesting different phases of construction or repair over time. Resources did not allow for a more systematic excavation in this area.

Aerial view of stupa and outer platform (left), trial trenches (centre) and secondary stupa (right) during conservation 2022

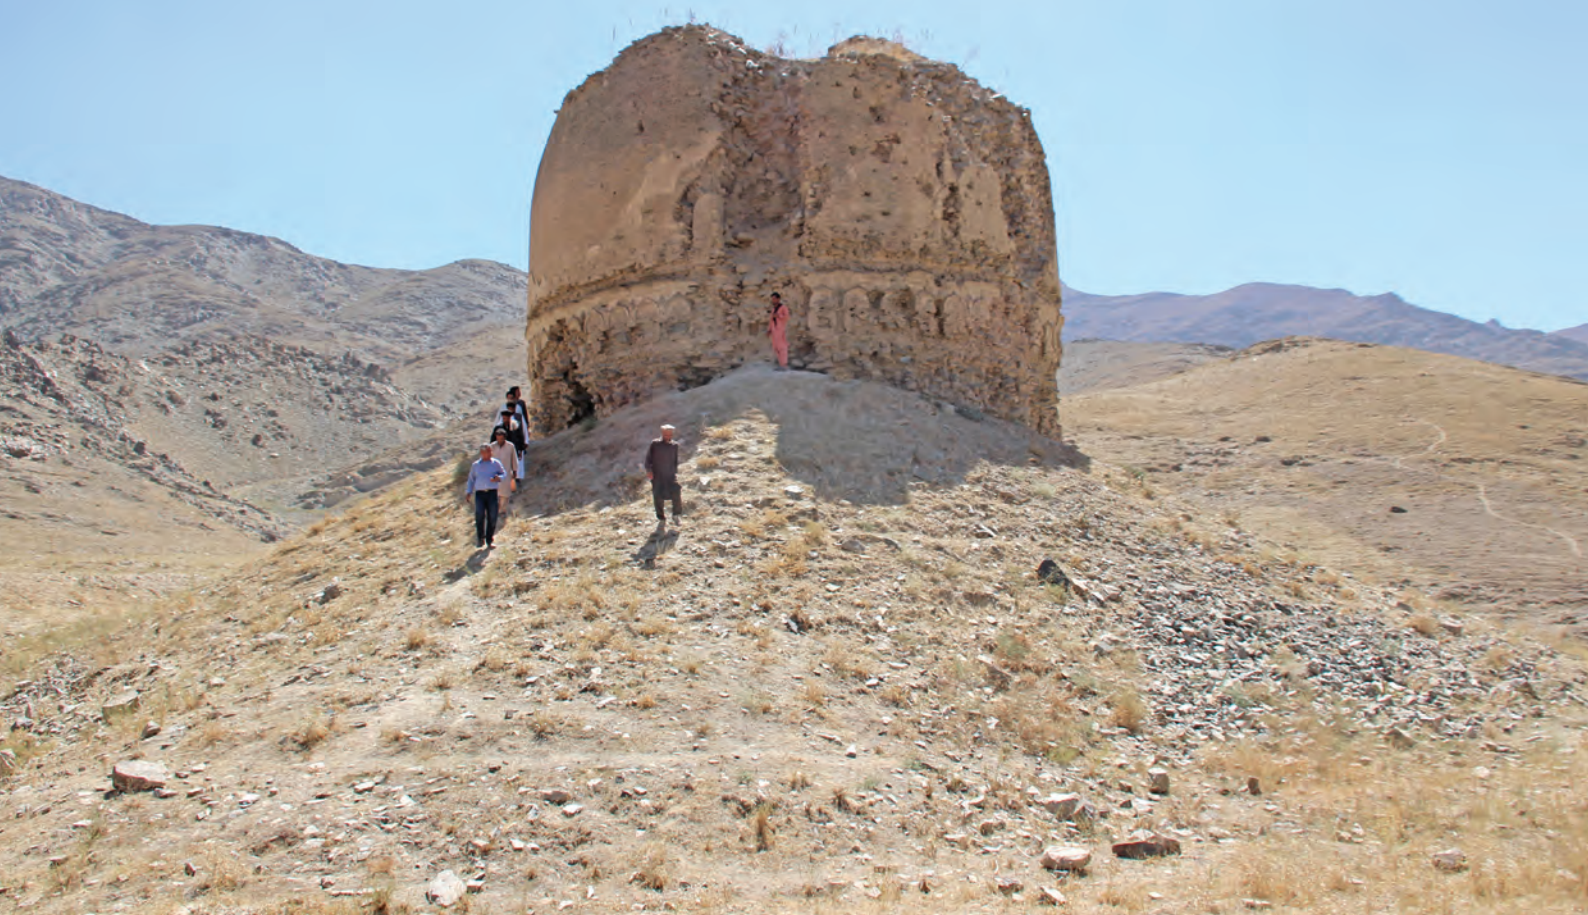
North elevation of Shewaki stupa, prior to (2020) and after conservation (2022).

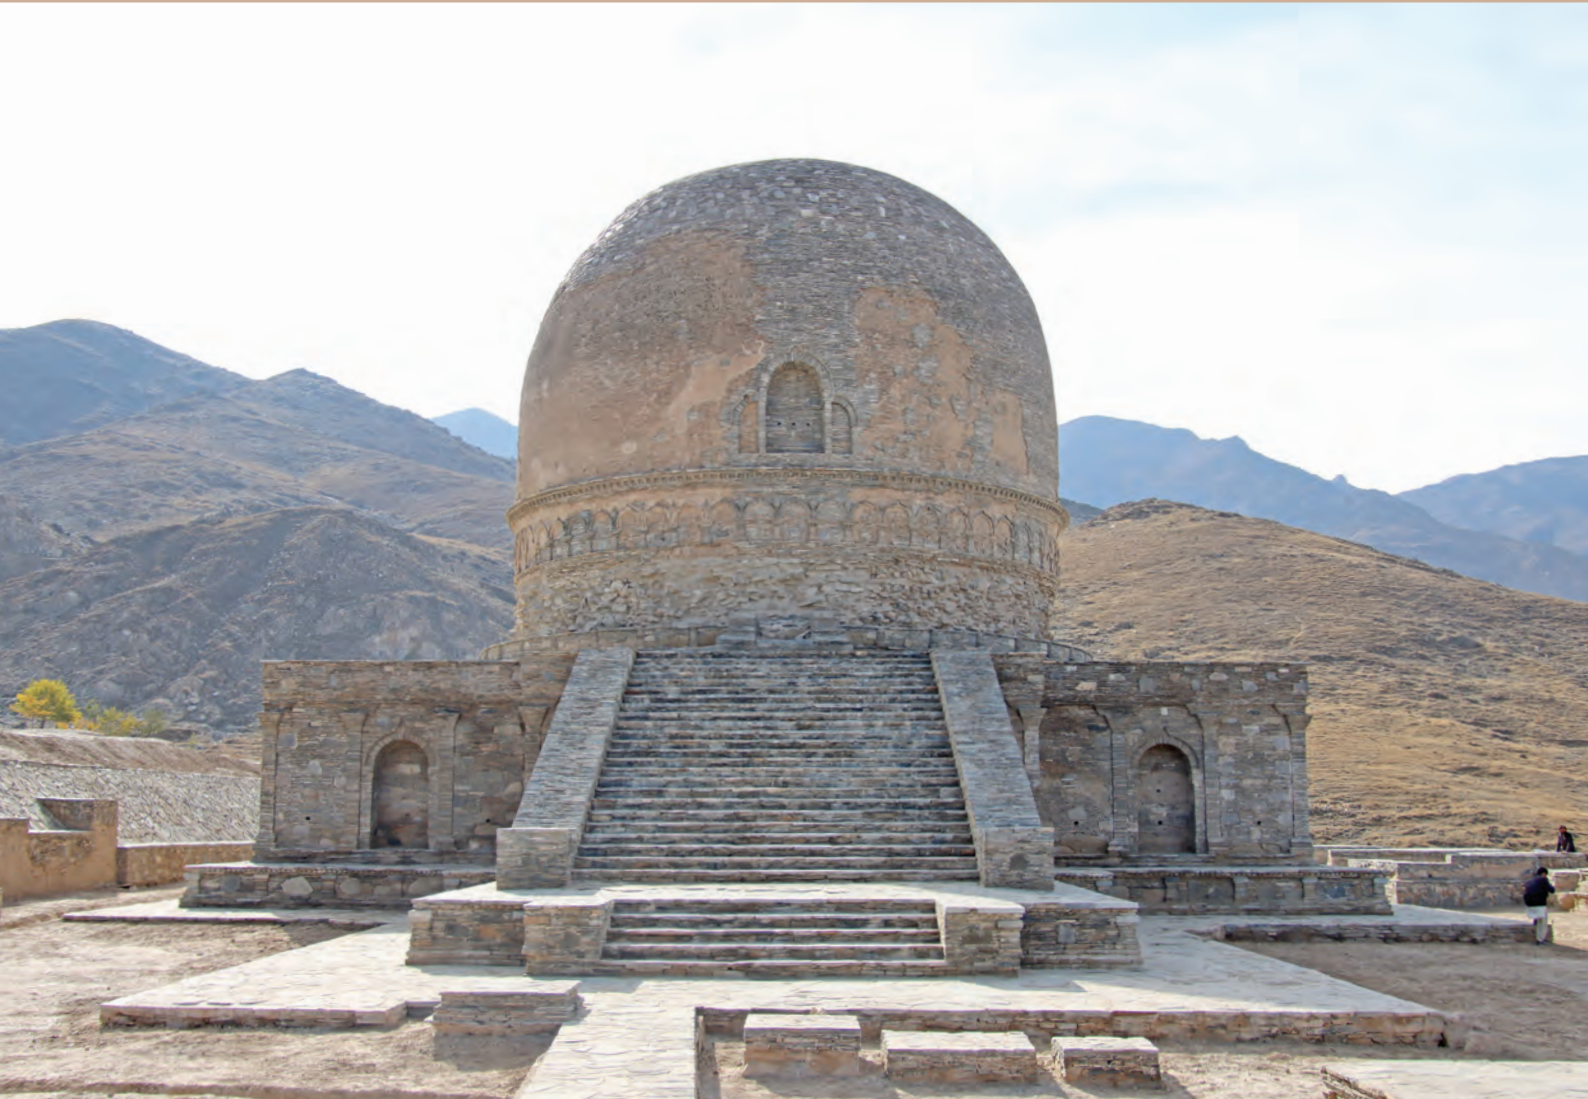
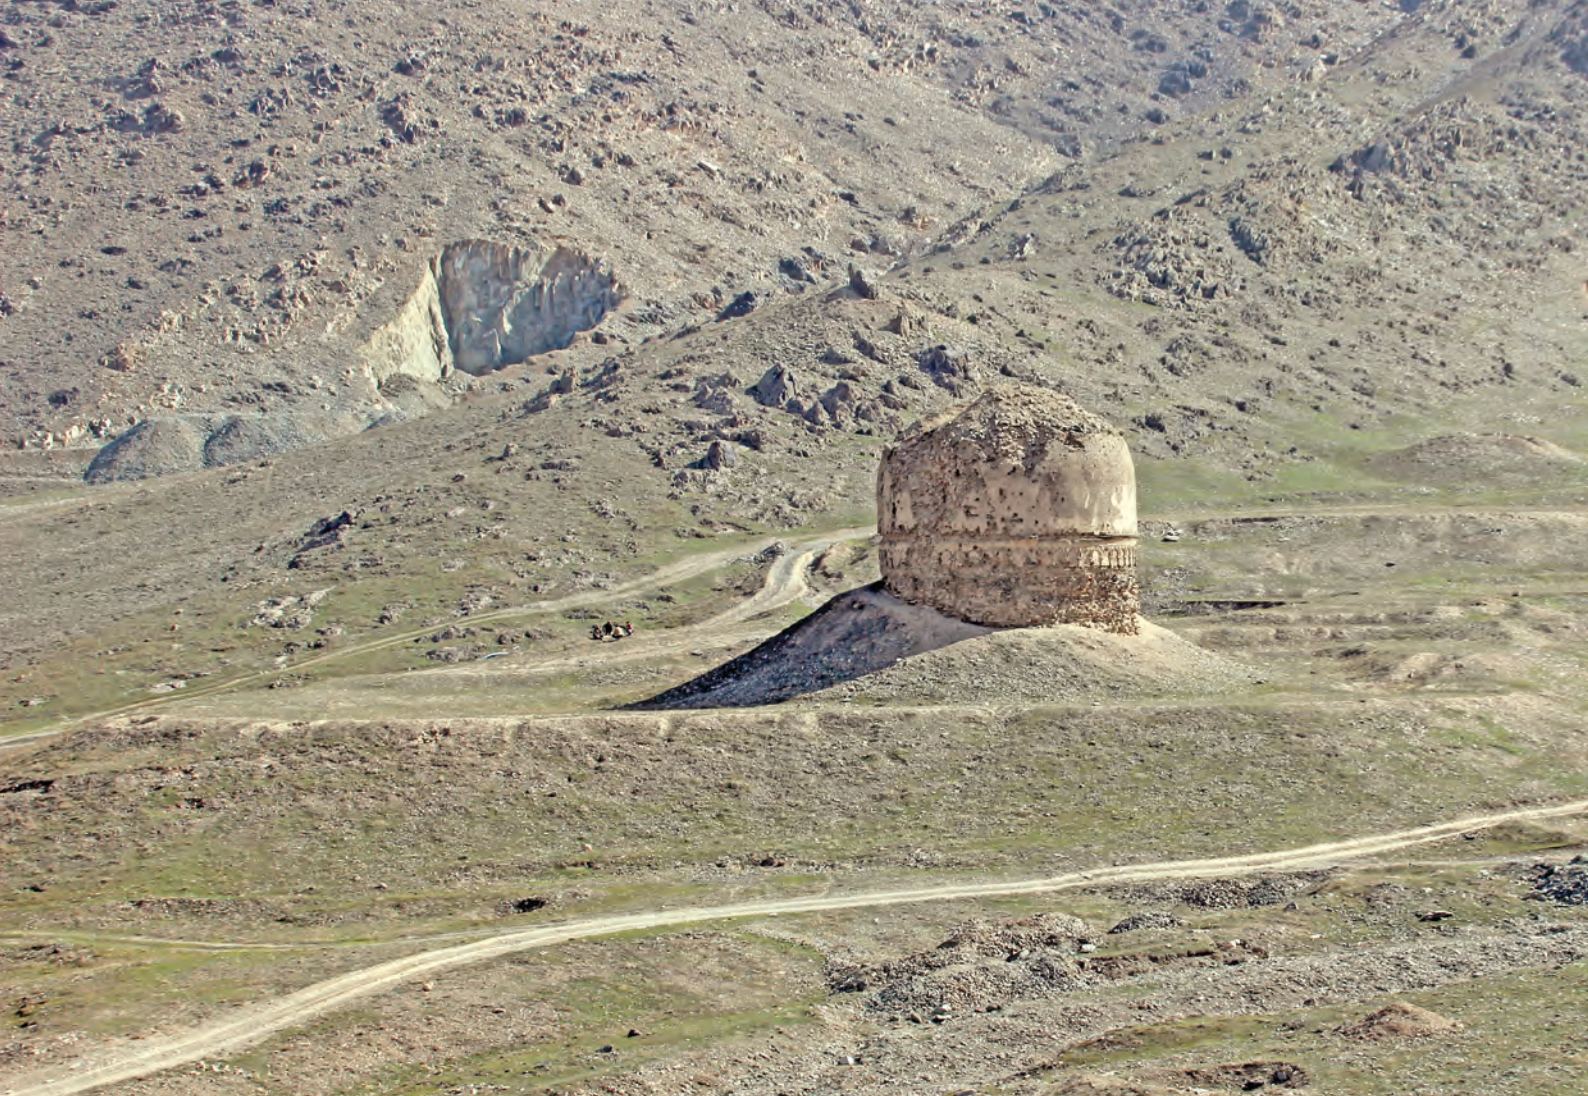
General view from the west, prior to (2020) and after conservation (2022).

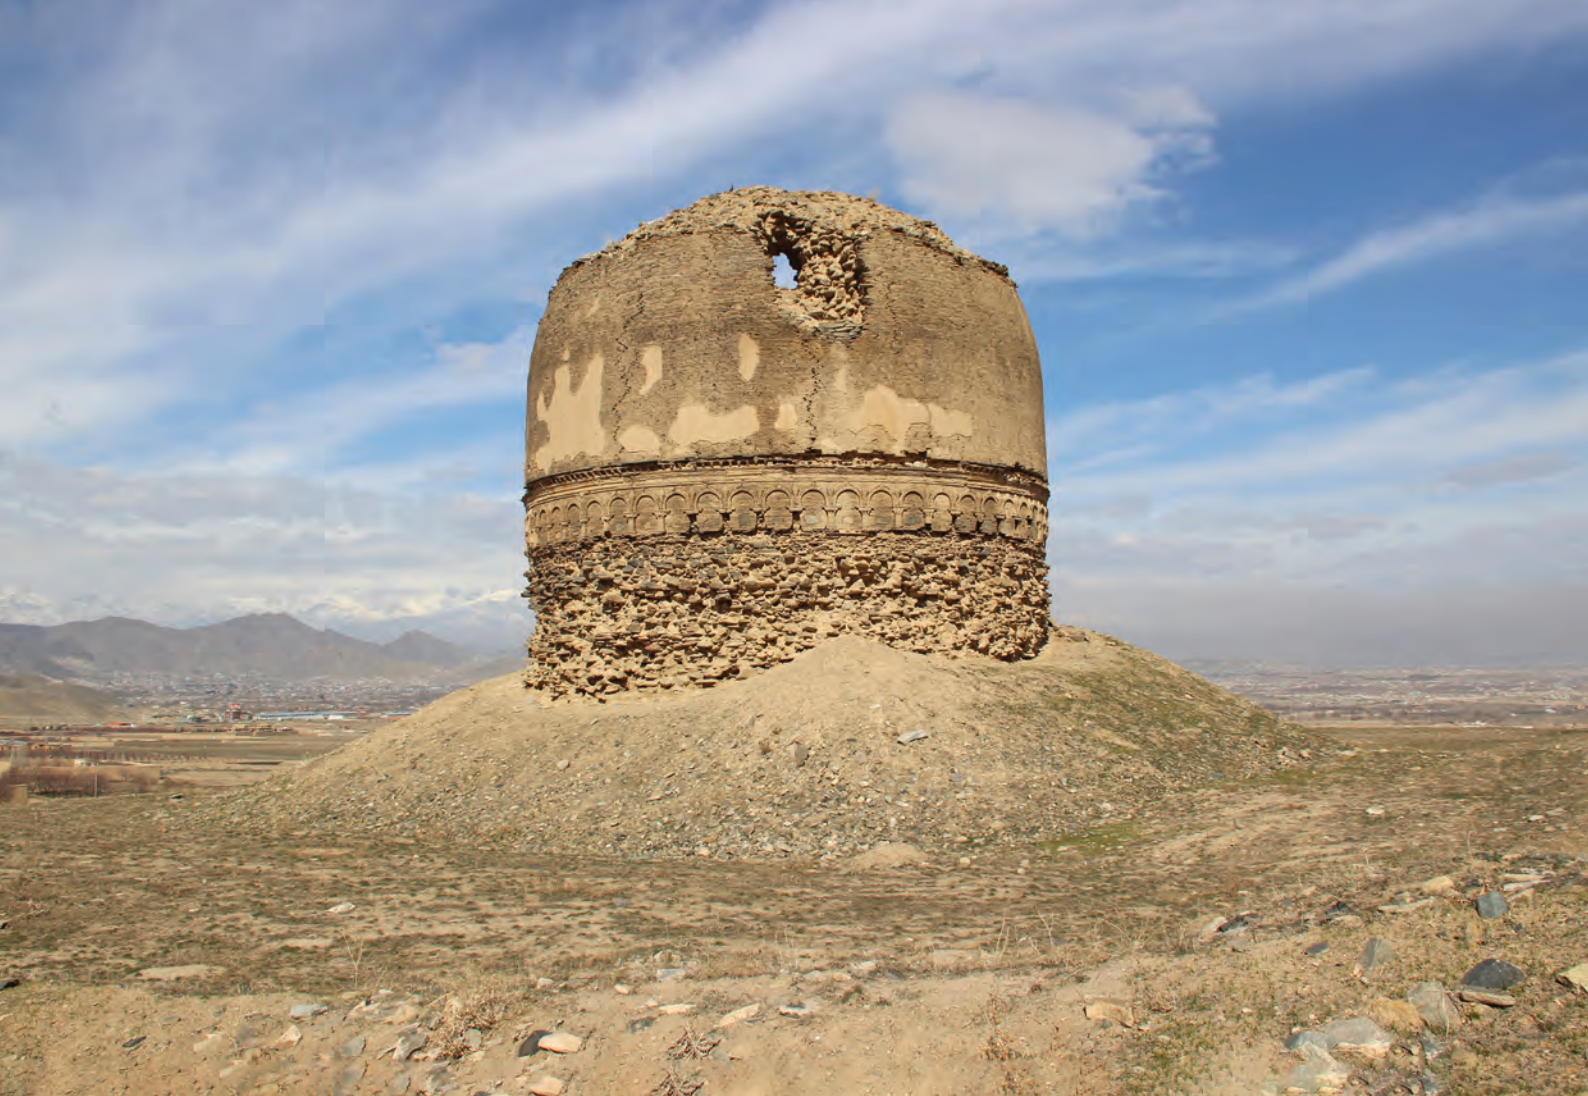
View of stupa and platform from south-east prior to (above) and after conservation (below).

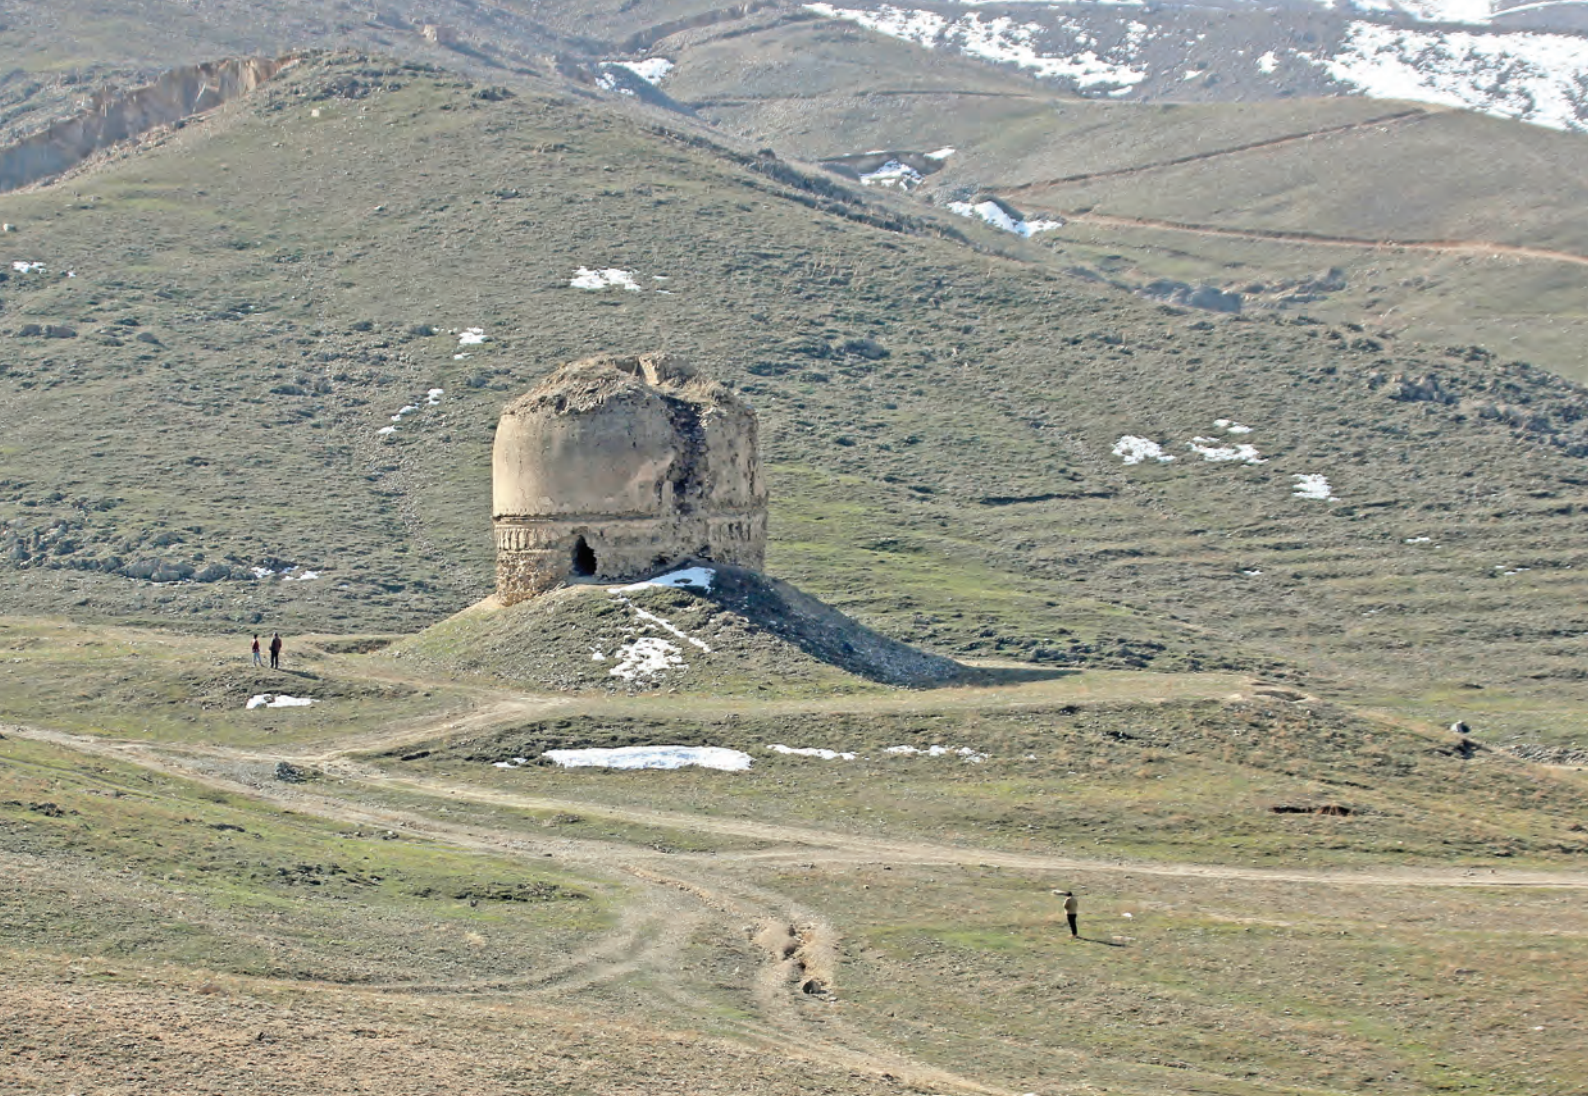
View of stupa and outer platform from north-east prior to (above) and after conservation (below). نمای شمال شرقی استوپه، قبل (بالا) و بعد از مرمت (پائین).
